Flood Control Project Maintenance
2009 Structure Summary Report
Overall Unit and Item Ratings

Turlock Irrigation District Gomes Lake

Gomes Lake Pumping Plant

Flood Control Project Maintenance**Unit Cover Sheet****2009 Pumping Plant Inspection Results****Turlock Irrigation District Gomes Lake**

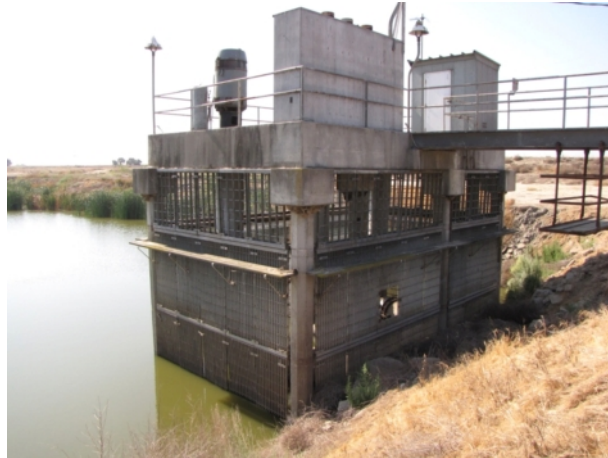
Levee Mile Report Line	3
Start Levee Mile	0.00
End Levee Mile	0.00
Location	
Category	Pump Stations
Item	Plant Building
View of the pump plant structure from the north west.	
dpesaven_20090820_60.jpg

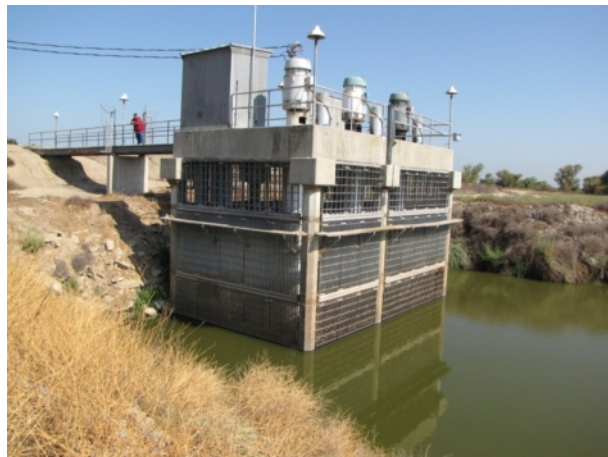
Levee Mile Report Line	3
Start Levee Mile	0.00
End Levee Mile	0.00
Location	
Category	Pump Stations
Item	Plant Building
View of the pump plant structure from the south-east.	
dpesaven_20090820_61.jpg

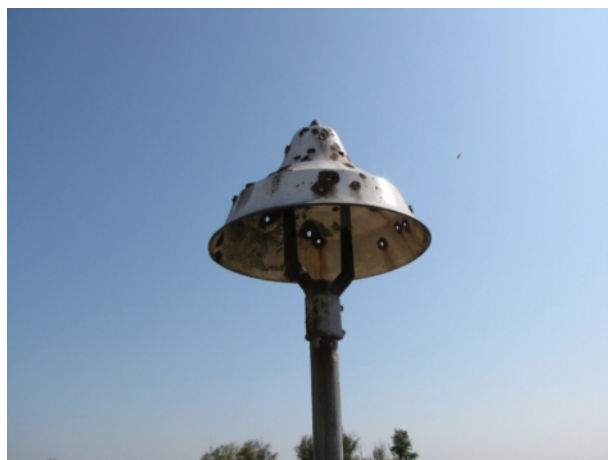
LMR No.	Levee Mile		Category	Item	Location	Rating	Action/Comment	GPS Latitude/Longitude		Photo	Issue No.
	Start	End						Start	End		
1	0.00	0.00	Pump Stations	Operating Log		A	Inspector Comments: A copy is kept at office, will bring a copy to the station ASAP.	°	°		1
2	0.00	0.00	Pump Stations	Operation & Maintenance Manual		A	Inspector Comments: A copy is kept at office, will bring a copy to the station ASAP.	°	°		2
3	0.00	0.00	Pump Stations	Plant Building		A	Inspector Comments: The plant is maintained in good condition with no apparent issues that would affect the operation. Minor vandalism occurs, mostly bullet holes.	°	°	Y	3
4	0.00	0.00	Pump Stations	Communications		A	Inspector Comments: Personnel carry cell phones.	°	°		4
5	0.00	0.00	Pump Stations	Safety		A	Inspector Comments: There were no significant hazards to plant personnel observed. The lights at the plant have been shot out, but maintenance staff are unable to prevent any installed lights from being shot at.	°	°	Y	5

Levee Mile Report Line	5
Start Levee Mile	0.00
End Levee Mile	0.00
Location	
Category	Pump Stations
Item	Safety
View of one of the lights at the plant that have been shot out.	
dpesaven_20090820_62.jpg

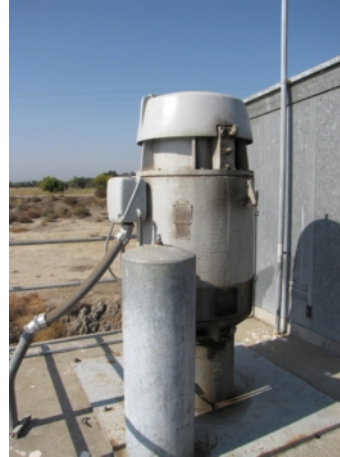
Levee Mile Report Line	7
Start Levee Mile	0.00
End Levee Mile	0.00
Location	
Category	Pump Stations
Item	Pumps

6	0.00	0.00	Pump Stations	Cranes		N	Inspector Comments: There is no crane at this station.	°	°		6
7	0.00	0.00	Pump Stations	Pumps		A	Item inspected visually only. Item was not operated during the inspection. Inspector Comments: During the previous month's testing, one of the pumps was not properly. Repair is scheduled in a couple days. The other two pumps were reported as operational but were not turned on during this inspection.	°	°	Y	7
8	0.00	0.00	Pump Stations	Power		A	Item inspected visually only. Item was not operated during the inspection. Inspector Comments: The maintaining agency is also the power provider for this plant and can prioritize any necessary repairs to the power grid or provide other generating methods.	°	°	Y	8
9	0.00	0.00	Pump Stations	Motors, Engines, Fans & Gear Reducers		N	Inspector Comments: There are no electrical or mechanical motors at this plant other than the pumps and gate operators.	°	°		9

View of pump #1.

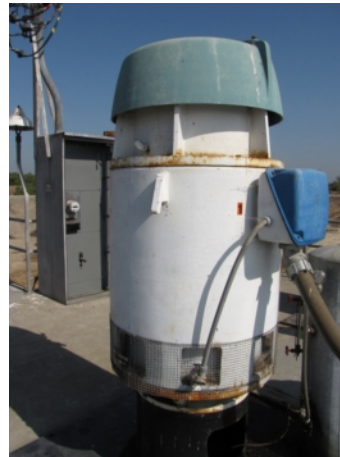
Levee Mile Report Line	7
Start Levee Mile	0.00
End Levee Mile	0.00
Location	
Category	Pump Stations
Item	Pumps

View of pump #2.

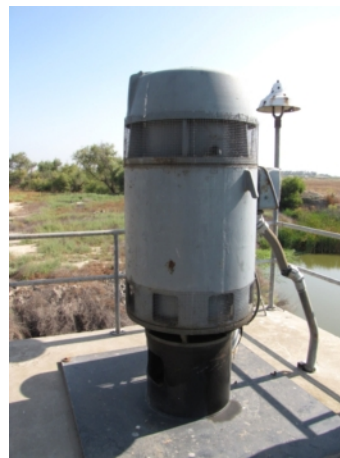
Levee Mile Report Line	7
Start Levee Mile	0.00
End Levee Mile	0.00
Location	
Category	Pump Stations
Item	Pumps

View of pump #3.

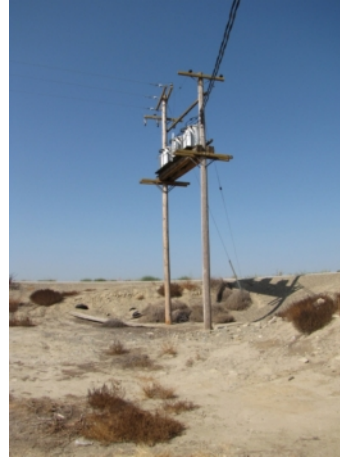
Levee Mile Report Line	8
Start Levee Mile	0.00
End Levee Mile	0.00
Location	
Category	Pump Stations
Item	Power

View of the electrical supply and transformers for the pump plant.

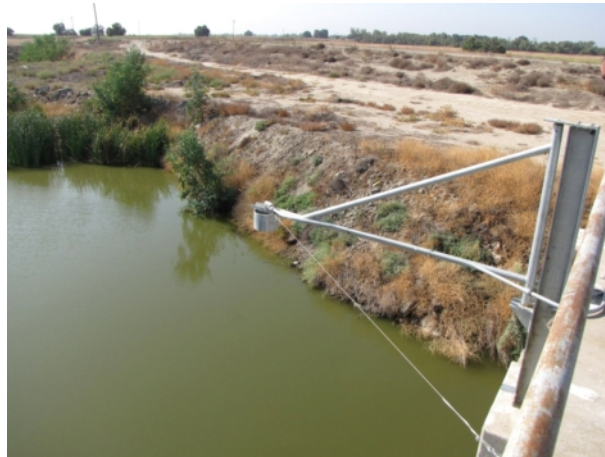
Levee Mile Report Line	10
Start Levee Mile	0.00
End Levee Mile	0.00
Location	
Category	Pump Stations
Item	Pump Control Systems

10	0.00	0.00	Pump Stations	Pump Control Systems		A	Item inspected visually only. Item was not operated during the inspection. Inspector Comments: The equipment appeared to be well maintained and operational.	°	°	Y	10
11	0.00	0.00	Pump Stations	Sumps/Wet Well		A	Inspector Comments: No debris was observed in the sump area.	°	°	Y	11

View of the new sonar water level sensor.

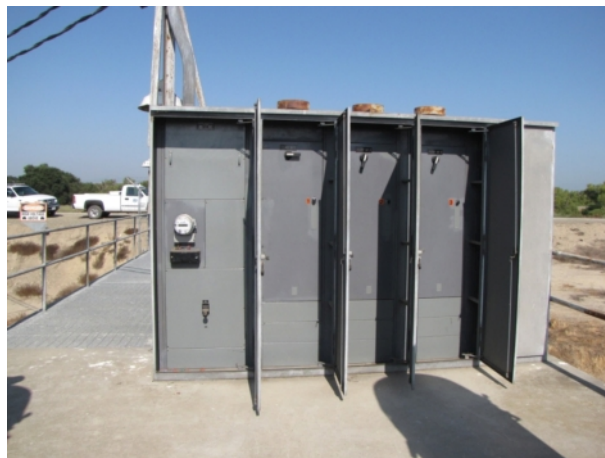
Levee Mile Report Line	10
Start Levee Mile	0.00
End Levee Mile	0.00
Location	
Category	Pump Stations
Item	Pump Control Systems

View of the power/pump control panel.

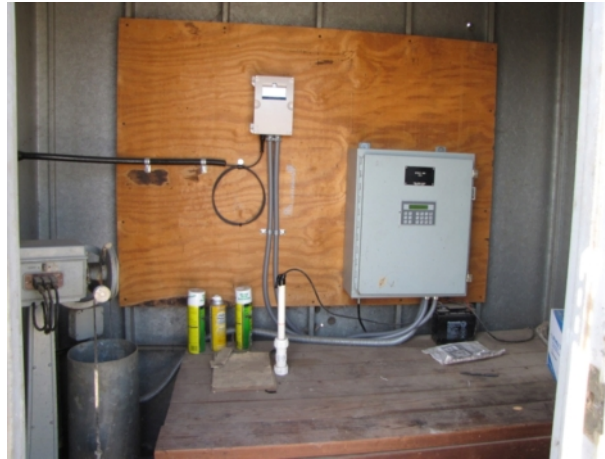
Levee Mile Report Line	10
Start Levee Mile	0.00
End Levee Mile	0.00
Location	
Category	Pump Stations
Item	Pump Control Systems

View of the water level detecting equipment and SCADA. Note the new sonar equipment on the center of the board.

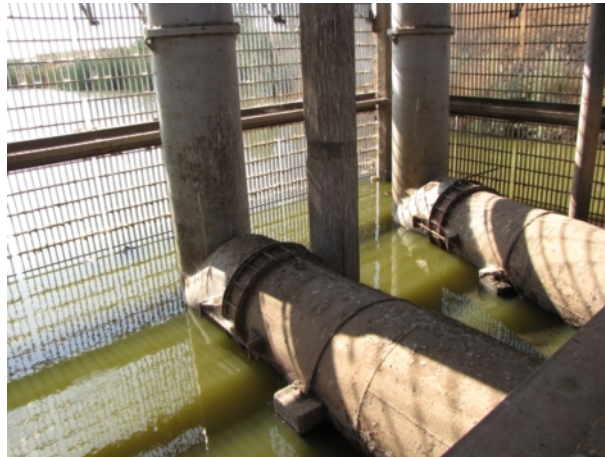
Levee Mile Report Line	11
Start Levee Mile	0.00
End Levee Mile	0.00
Location	
Category	Pump Stations
Item	Sumps/Wet Well

View of the sump under pumps #1 and 2.

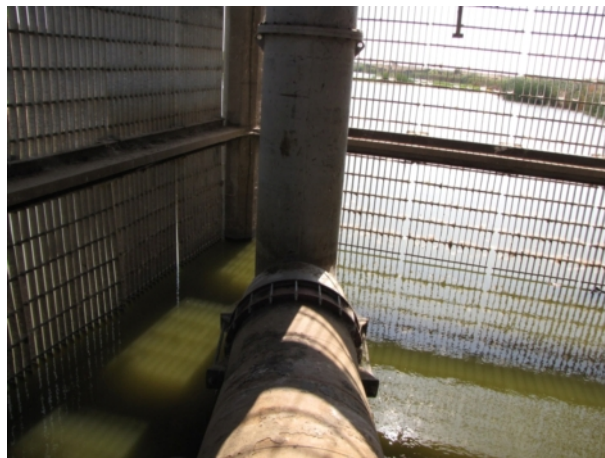
Levee Mile Report Line	11
Start Levee Mile	0.00
End Levee Mile	0.00
Location	
Category	Pump Stations
Item	Sumps/Wet Well

View of the sump under pump #3.

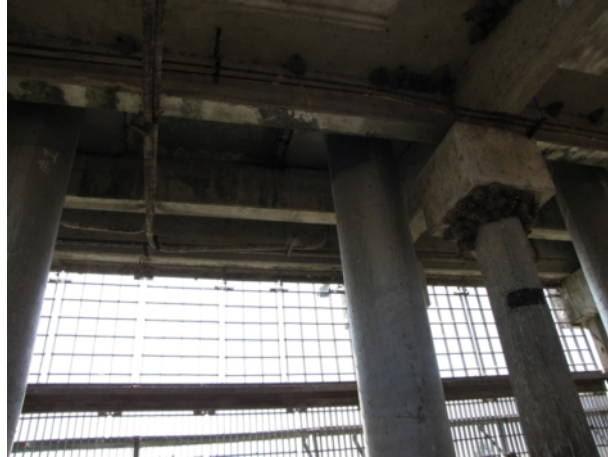
Levee Mile Report Line	11
Start Levee Mile	0.00
End Levee Mile	0.00
Location	
Category	Pump Stations
Item	Sumps/Wet Well

View of the underside of the station platform from the sump.

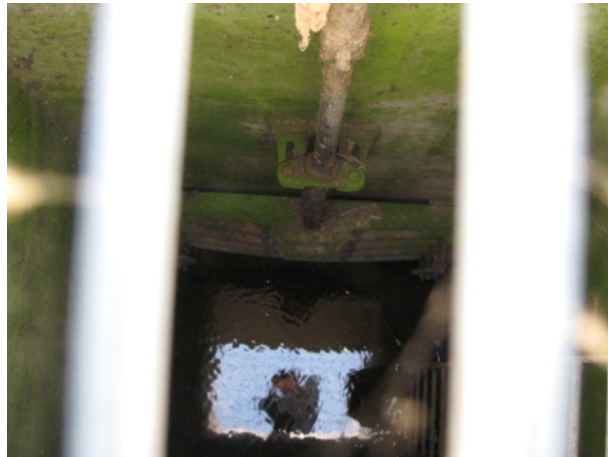
Levee Mile Report Line	14
Start Levee Mile	0.00
End Levee Mile	0.00
Location	
Category	Pump Stations
Item	Sluice / Slide Gates

View of one of the slide gates.

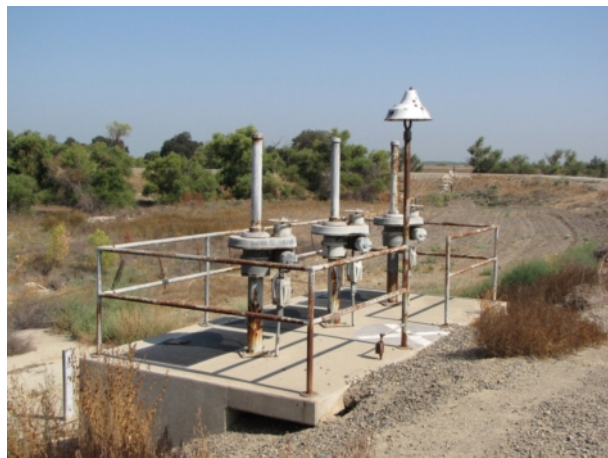
Levee Mile Report Line	16
Start Levee Mile	0.00
End Levee Mile	0.00
Location	
Category	Pump Stations
Item	Manual Gate Operators

16	0.00	0.00	Pump Stations	Manual Gate Operators		M	Inspector Comments: The manual operators were not able to be engaged during this inspection and no tools were available to assist. The operators should be periodically greased and operated to ensure functionality if electrical power is not available.	°	°	Y	16
17	0.00	0.00	Pump Stations	Other Metallic Items		A	Inspector Comments: Some rust was observed on the handrails and other metal at the plant, but none that would affect the performance of the plant.	°	°		17
18	0.00	0.00	Pump Stations	Flap Gates		A	Inspector Comments: The flap gates appeared to be capable of performing as intended.	°	°	Y	18
19	0.00	0.00	Pump Stations	Closure Structures		N	Inspector Comments: There are no closure structures at this plant.	°	°		19
20	0.00	0.00	Pump Stations	Security Fencing		A	Inspector Comments: The plant has a gate capable of restricting access to the pumps.	°	°		20

View of the gate operators.

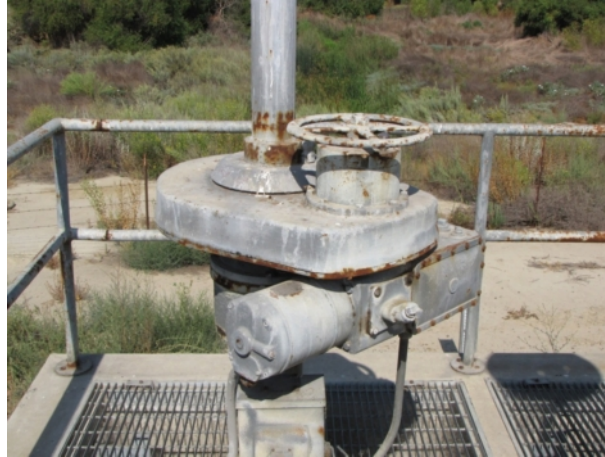
Levee Mile Report Line	16
Start Levee Mile	0.00
End Levee Mile	0.00
Location	
Category	Pump Stations
Item	Manual Gate Operators

Closer view of one of the gate operators.

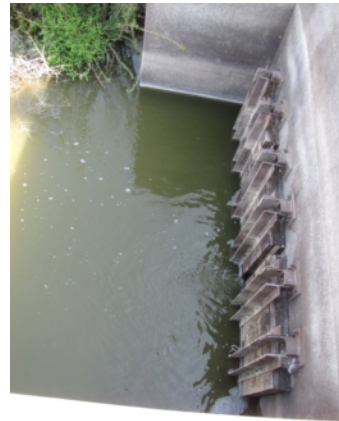
Levee Mile Report Line	18
Start Levee Mile	0.00
End Levee Mile	0.00
Location	
Category	Pump Stations
Item	Flap Gates

View of the outfall and flap gates.
